**SERVICE BULLETIN RCA 2020-03-17**

**Date:** 17 March 2020  
**Subject:** Reprint of Vans Aircraft SB 19-09-09  
**Affected Aircraft:** Robin Coss Aviation RV10 aircraft completed between 2006 and 2020 as listed below.

**SERVICE BULLETIN 19-09-09**

**Date Released:** February 26, 2020  
**Date Effective:** February 26, 2020  
**Subject:** Cracking of RV-10 nose gear leg inboard attach lug  
**Affected Models:** RV-10 flying aircraft and/or Finish Kits shipped prior to October 1, 2019  
**Required Action:** Inspect the inboard attachment lugs of the WD-1017 Nose Landing Gear for cracks (see Figure 1). If cracks are discovered, replace the WD-1017 Nose Landing Gear with the WD-1017-1 Nose Landing Gear as described in this document. If no cracks are discovered, annual inspections are required.

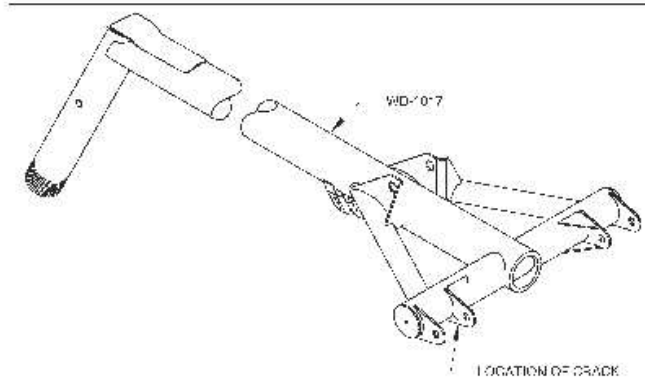
**FIGURE 1: INBOARD LUG CRACK LOCATION**

**Synopsis:** A crack was discovered in the inboard attachment lug of the nose landing gear on an aircraft that operates from a grass field and which had acquired more than 1700 hours of flight time. Only a single instance has been reported.

**Accomplishing Instructions:** Inspect the nose landing gear leg inboard attachment lugs per attached Vans Aircraft SB 19-09-09. If a crack is discovered contact Robin Coss Aviation or Vans Aircraft to arrange for replacement of the WD-1017 Nose Gear Leg assembly with a new WD-1017-1 Nose Gear Leg. Replace the gear leg assembly as per instructions contained in Vans Aircraft SB 19-09-09. If no crack is discovered reinspect every 100hrs/annual whichever comes first until the WD-1017 Nose Gear Leg is replaced with a WD-1017-1 Nose Gear Leg.

**NOTE:** This gear leg is heat treated. Welding as a method of repair is not approved.
