SERVICE BULLETIN RCA 2019-03-26

Subject: Reprint of Slick/Champion Aerospace SB1-15A and Lycoming MSB622A

Affected Aircraft: All RV6/6A; RV7/7A; RV8/8A; RV9/9A; RV14/14A aircraft equipped with 4200, 4300, or 4700 (LASAR) magnetos with magneto serial numbers 08090001 thru 16071072 as well as any K3822 distributor block replacement kits, and K3008 distributor gear assemblies dated September 26, 2008 through September 1, 2016 installed in any magneto during maintenance.

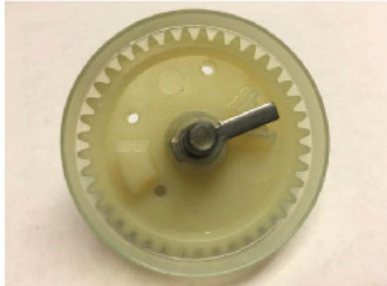
<p>Figure 5. K3008 Distributor Gear With Monel Electrode</p>																								
PROOF OF COMPLIANCE:	<p>Appropriate logbook entries. See SB 1-15A "COMPLIANCE" and "WARRANTY INFORMATION". Make sure that the removed affected part is returned to Champion through the normal warranty process.</p>																							
MAINTENANCE PARTS AFFECTED:	<ul style="list-style-type: none"> • Any 4200 series, 4300 series or 4700 series (LASAR) magnetos which have had the distributor block assembly replaced with a K3822 distributor block replacement kit dated Sept. 26, 2008 thru Sept. 1, 2016 installed as part of a repair • Individual K3822 distributor block replacement kits dated Sept. 26, 2008 thru Sept. 1, 2016 • Individual K3008 distributor gear replacement kits dated Sept. 26, 2008 thru Sept. 1, 2016
