SERVICE BULLETIN RCA 2019-08-07

Subject: Reprint of Dynon Avionics SB 080219

Affected Aircraft: RV10 aircraft constructed after 13 December 2011 fitted with a Dynon Avionics autopilot system or any RV10 aircraft retrofitted with a Dynon Avionics autopilot system that includes an SV42T servo shipped from Dynon after 13 December 2011. Note: The SV42T servo is not used on any other model RV constructed by Robin Coss Aviation.

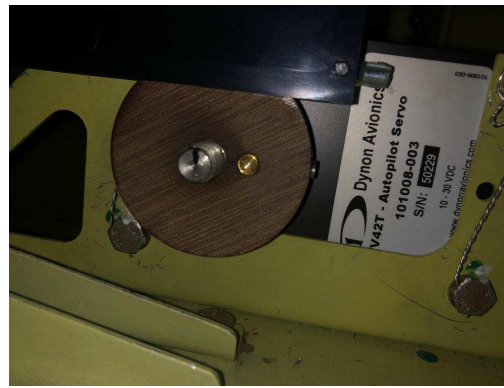
Figure 2

Note: The cotter pin, castellated nut, wave washer and nylon washer should be removed from the servo shaft for proper inspection of the area between the centre pulley hole and the shear screw bore (fig 2 & 3)

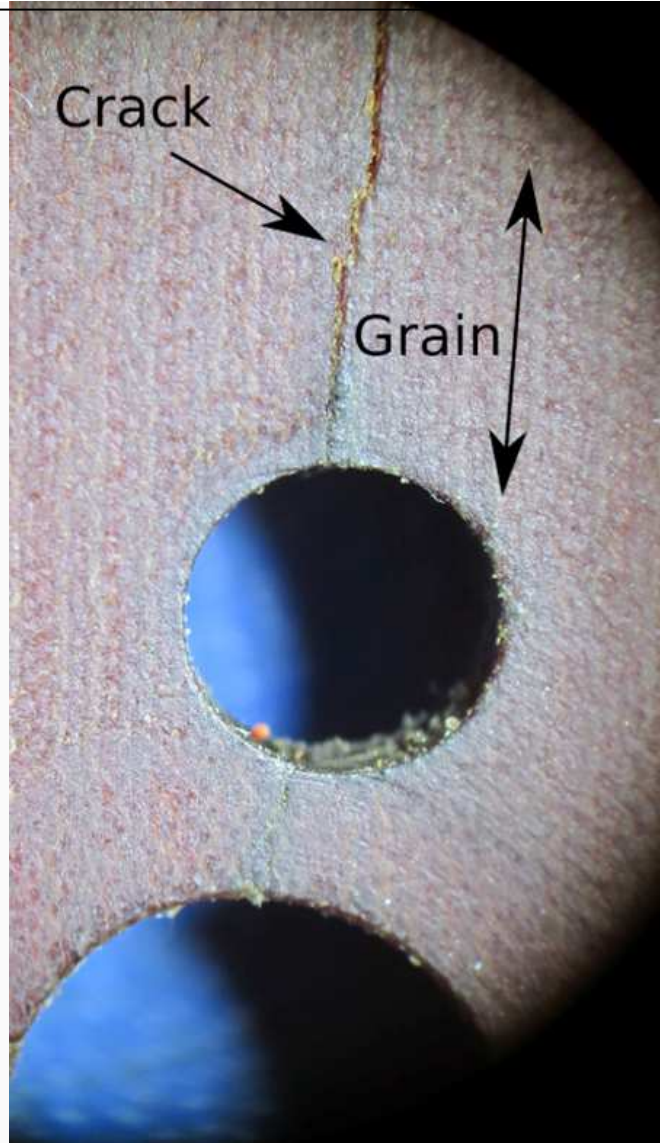
Dynon Avionics has received reports of cracked pulleys in the SV42T linear actuator servo. This can cause poor autopilot performance and presents a risk of interfering with the flight controls.

1. If you received your SV42T or linear actuator assembly before 12/13/2011, it is unaffected and can remain in service. If you received your servo, or linear actuator assembly after this date, inspect it as follows.
2. Inspect the pulley for a crack from the center of the pulley through shear screw bore. (Fig 2)
 - It may be necessary to engage the autopilot on the ground and apply force to the control surface in order to load the pulley to make the crack visible.
3. If a crack is found, remove the servo from service and return to Dynon for repair/replacement.
4. If no crack is found, inspect the pulley to determine whether it is affected:
 - Unaffected pulleys have a crosshatch weave pattern in their material weave and a plastic-like smooth texture. Inspect the pulley for texture and visually with a

Fig 2: Affected pulley design with crack

- Affected pulleys have a unidirectional wood-like “grain”, and a finish that appears dull looks similar to wood. If your pulley matches this description, remove from service and **contact Dynon** for repair/replacement. To remove the servo from service, you may opt to remove the entire servo assembly, or if more convenient you may remove the entire linear actuator sub-assembly by following the “Servo Arm / Capstan Removal and Replacement Instructions” on the **Dynon Documentation Website**. Whether you remove the servo or linear actuator, ensure that any remaining linkages are secured and do not interfere with flight controls. If you choose to remove only the linear actuator, disable the servo circuit electrically to prevent misleading autopilot behavior. This can be accomplished by disconnecting the wiring to the servo and/or removing its fuse or turning off its circuit breaker.

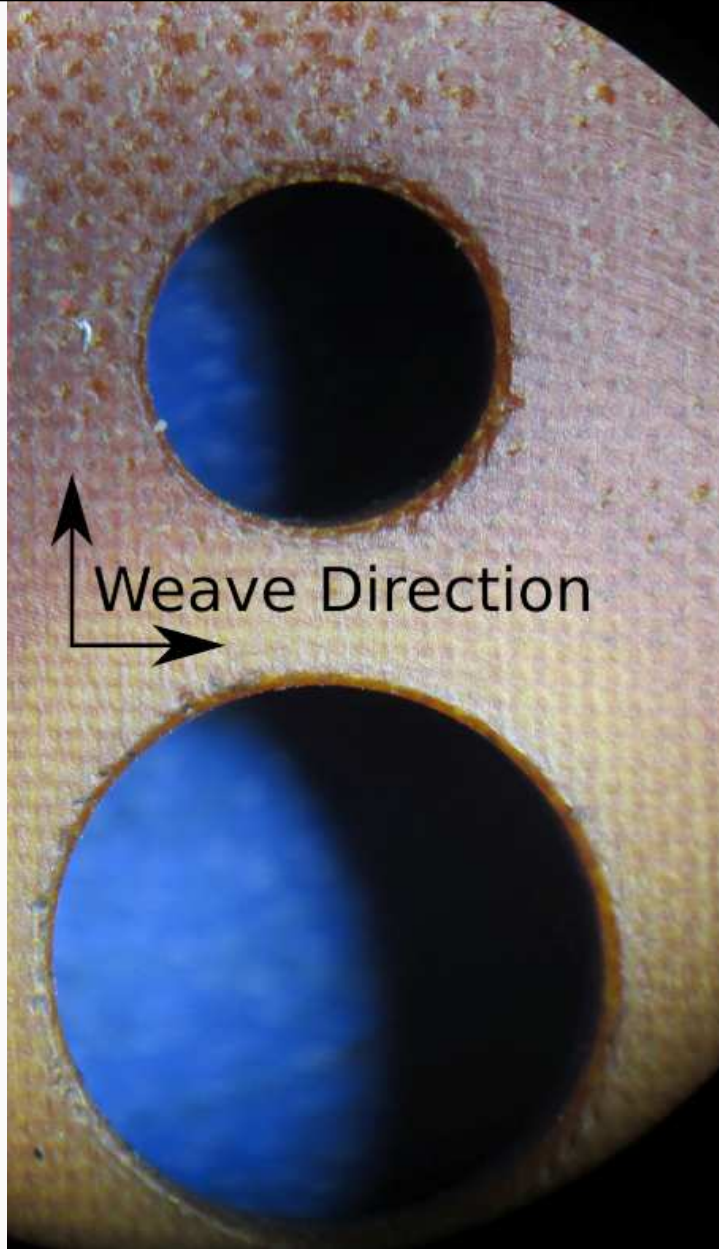
magnifier. If a crosshatch weave pattern is present (Fig 3), the pulley may remain in service.

Fig 3: Serviceable pulley design
