SERVICE BULLETIN RCA 2019-08-07

Subject: Reprint of Dynon Avionics SB 080219

Affected Aircraft: RV10 aircraft constructed after 13 December 2011 fitted with a Dynon Avionics autopilot system or any RV10 aircraft retrofitted with a Dynon Avionics autopilot system that includes an SV42T servo shipped from Dynon after 13 December 2011. Note: The SV42T servo is not used on any other model RV constructed by Robin Coss Aviation.

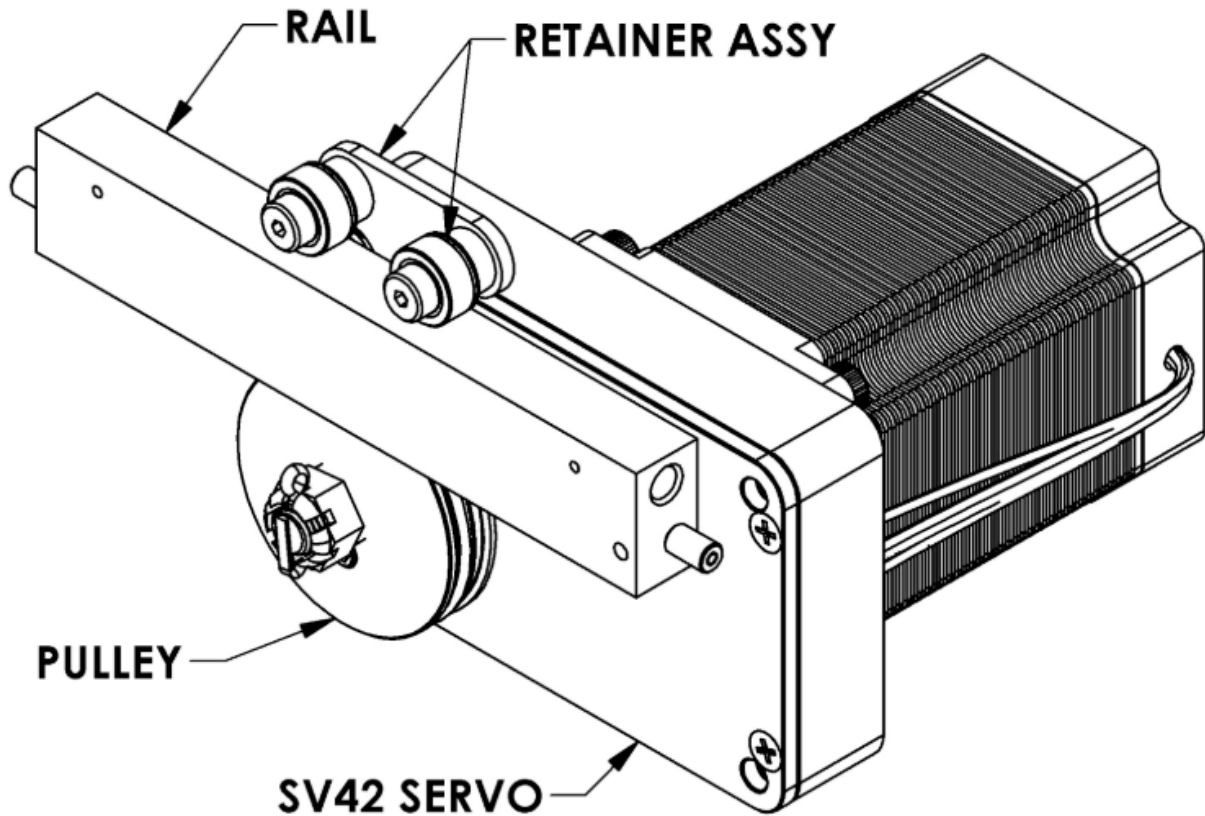
Fig 1: Dynon SV42T servo with linear actuator

Synopsis: Dynon Avionics has received reports of cracked pulleys in the SV42T linear actuator servo. This can cause poor autopilot performance and presents a risk of interfering with the elevator flight control. The SV42T servo is used for pitch control of the RV10 aircraft. The roll servo fitted to the RV10 is not an SV42T and is not affected by this SB.

Required Action: Removal of affected servos linear actuator sub-assembly for replacement of the pulley.

Gain access to the aircraft's autopilot pitch servo by removing the baggage area close-out panels (fig 1)
 Inspect the pitch servo per instructions contained in the "Solution" section of Dynon SB 080219 (attached)
